Work confirmation of the feed bar

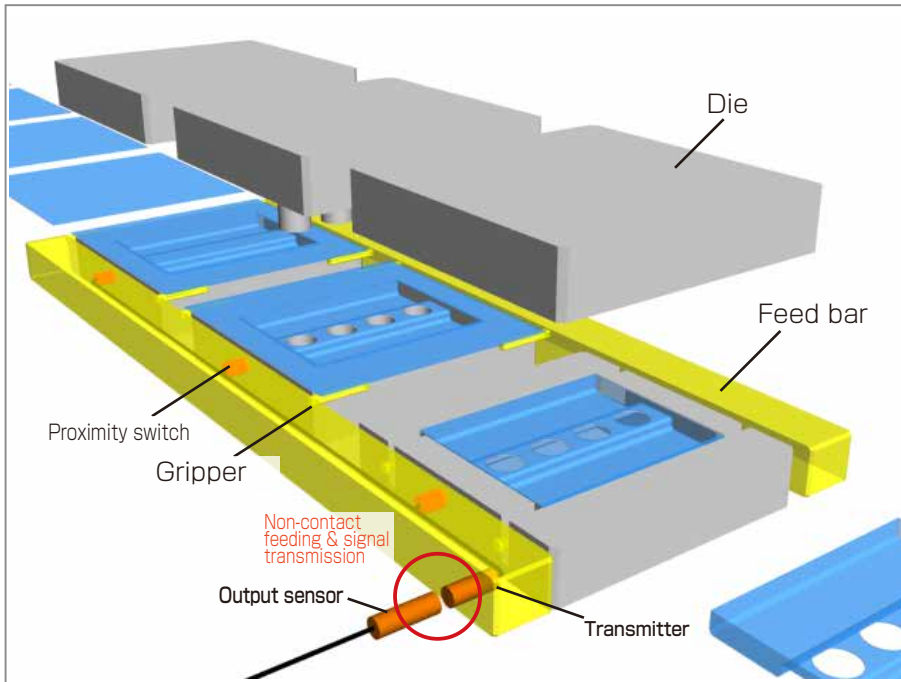
Previous problems

- Cable disconnection by the curve.
- Time loss caused by attaching or detaching of connector when exchanging die.

After improvement

- Efficiency of the exchange the feed bar.
- Resolution of the disconnection trouble.
- No problems in an environment of water or the oil.

Because of a kind and the placement of the gripper vary according to the press line using the feed bar, in the case of die exchange the feed bar changes as well. Because of the remote system the exchange work can be shortened.
